## AIRCRAFT GROUND-FLOTATION INVESTIGATION

### PART XIV — DATA REPORT ON TEST SECTION 14

TECHNICAL REPORT AFFDL-TR-66-43, PART XIV

SEPTEMBER 1966

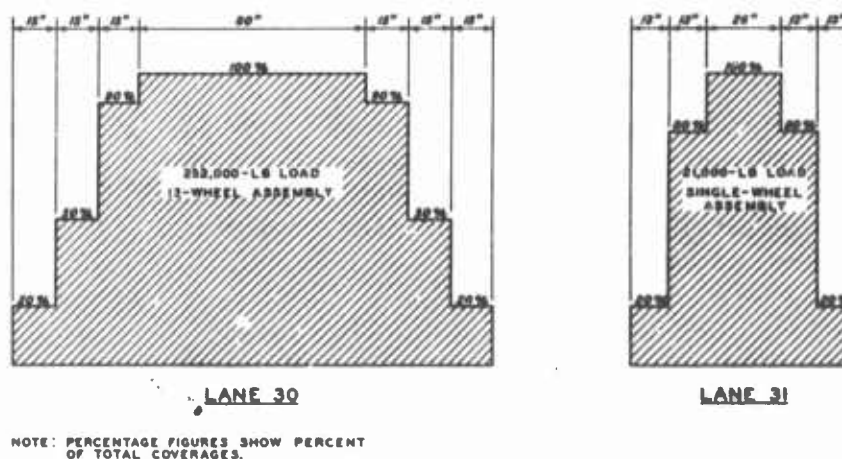
Figure 1. Traffic distribution patterns for Test Section 14

Traffic was applied to the test lanes in a nonuniform pattern with intensity of traffic being varied within each lane to produce approximately the bell-shaped traffic distribution curve which results from the wander of aircraft from the lane center line. In lane 30, the multiwheel traffic was distributed across the lane width in four zones of about 100, 90, 50, and 20 percent traffic coverage (figure 1). In lane 31, the single-wheel traffic was distributed across the lane width in three zones of about 100, 80, and 20 percent traffic coverage (figure 1). The coverage levels referred to in the tables and text herein are the total number of coverages applied to the 100 percent coverage zone. The corresponding number of coverages applied to the outer traffic zones is proportional to the percentage factor for the respective zones, as shown in figure 1.

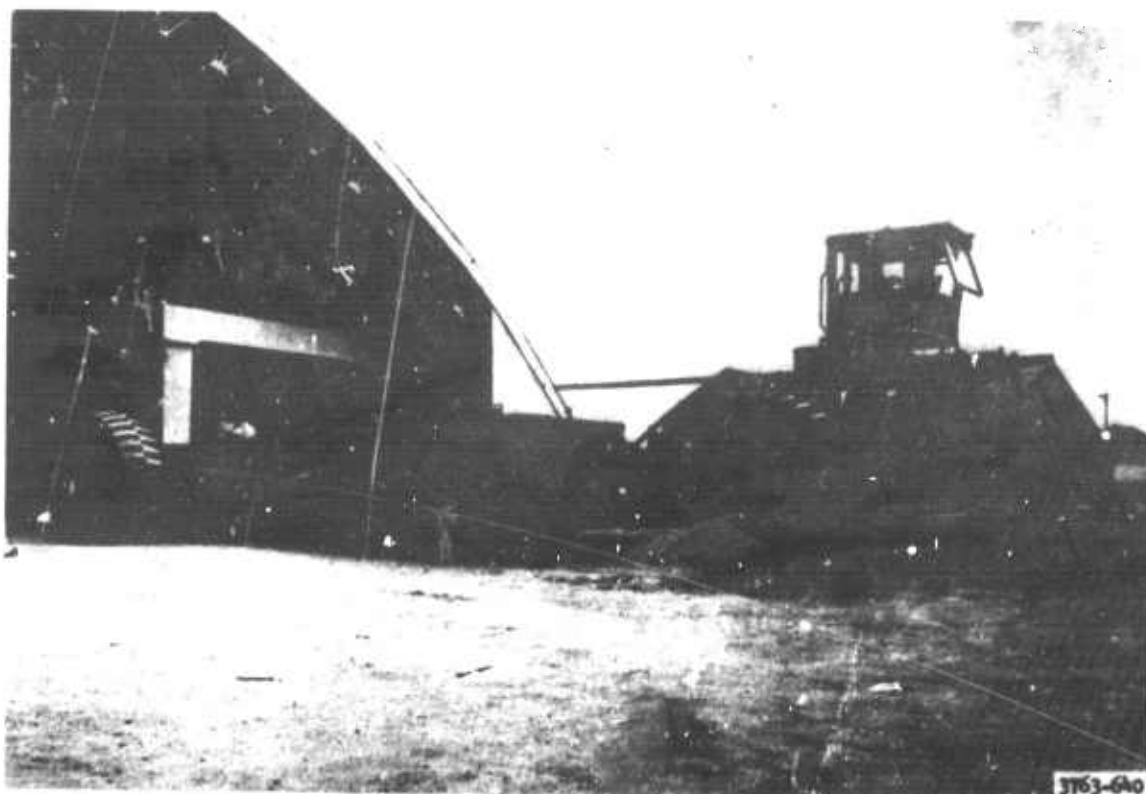
Figure 2. Test load vehicle used in trafficking lane 30

The multiwheel load vehicle used in trafficking lane 30 is shown in figure 2. This vehicle consists of an electrically powered prime mover with three load carts. The load carts are attached to the prime mover by a torsion bar, and to each other by parallel bars that maintain horizontal stability while allowing the load carts to oscillate vertically. The test load was 21,000 lb per wheel (a total load of 252,000 lb). The wheel assembly consisted of twelve 20.00-20, 22-ply aircraft tires inflated to a pressure of 100 psi. Typical tire-contact-area dimensions, overall assembly dimensions, and pertinent tire characteristics are shown in figure 14.

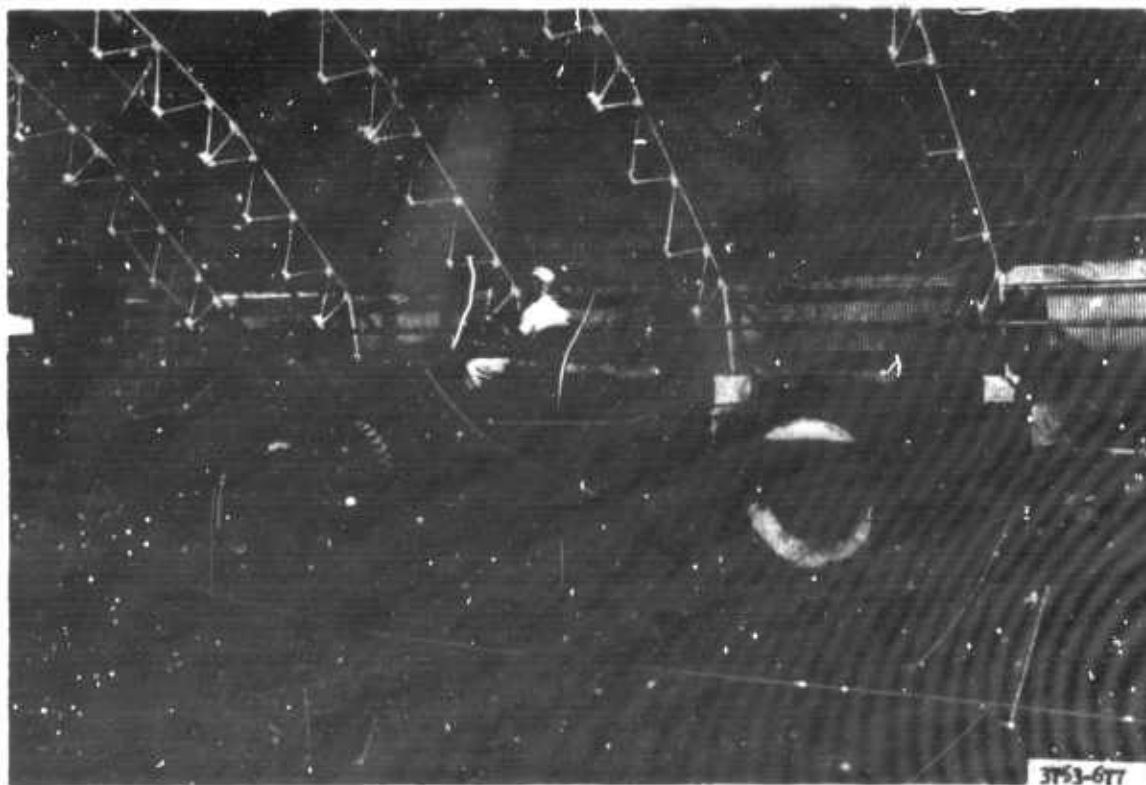
Figure 3. Test load vehicle used in trafficking lane 31

The total test load designated for lane 31 was 21,000 lb. The wheel assembly (figure 3) consisted of a 20.00-20, 22-ply aircraft tire with 100-psi inflation pressure. Tire-print data and pertinent tire characteristics are shown in figure 14.

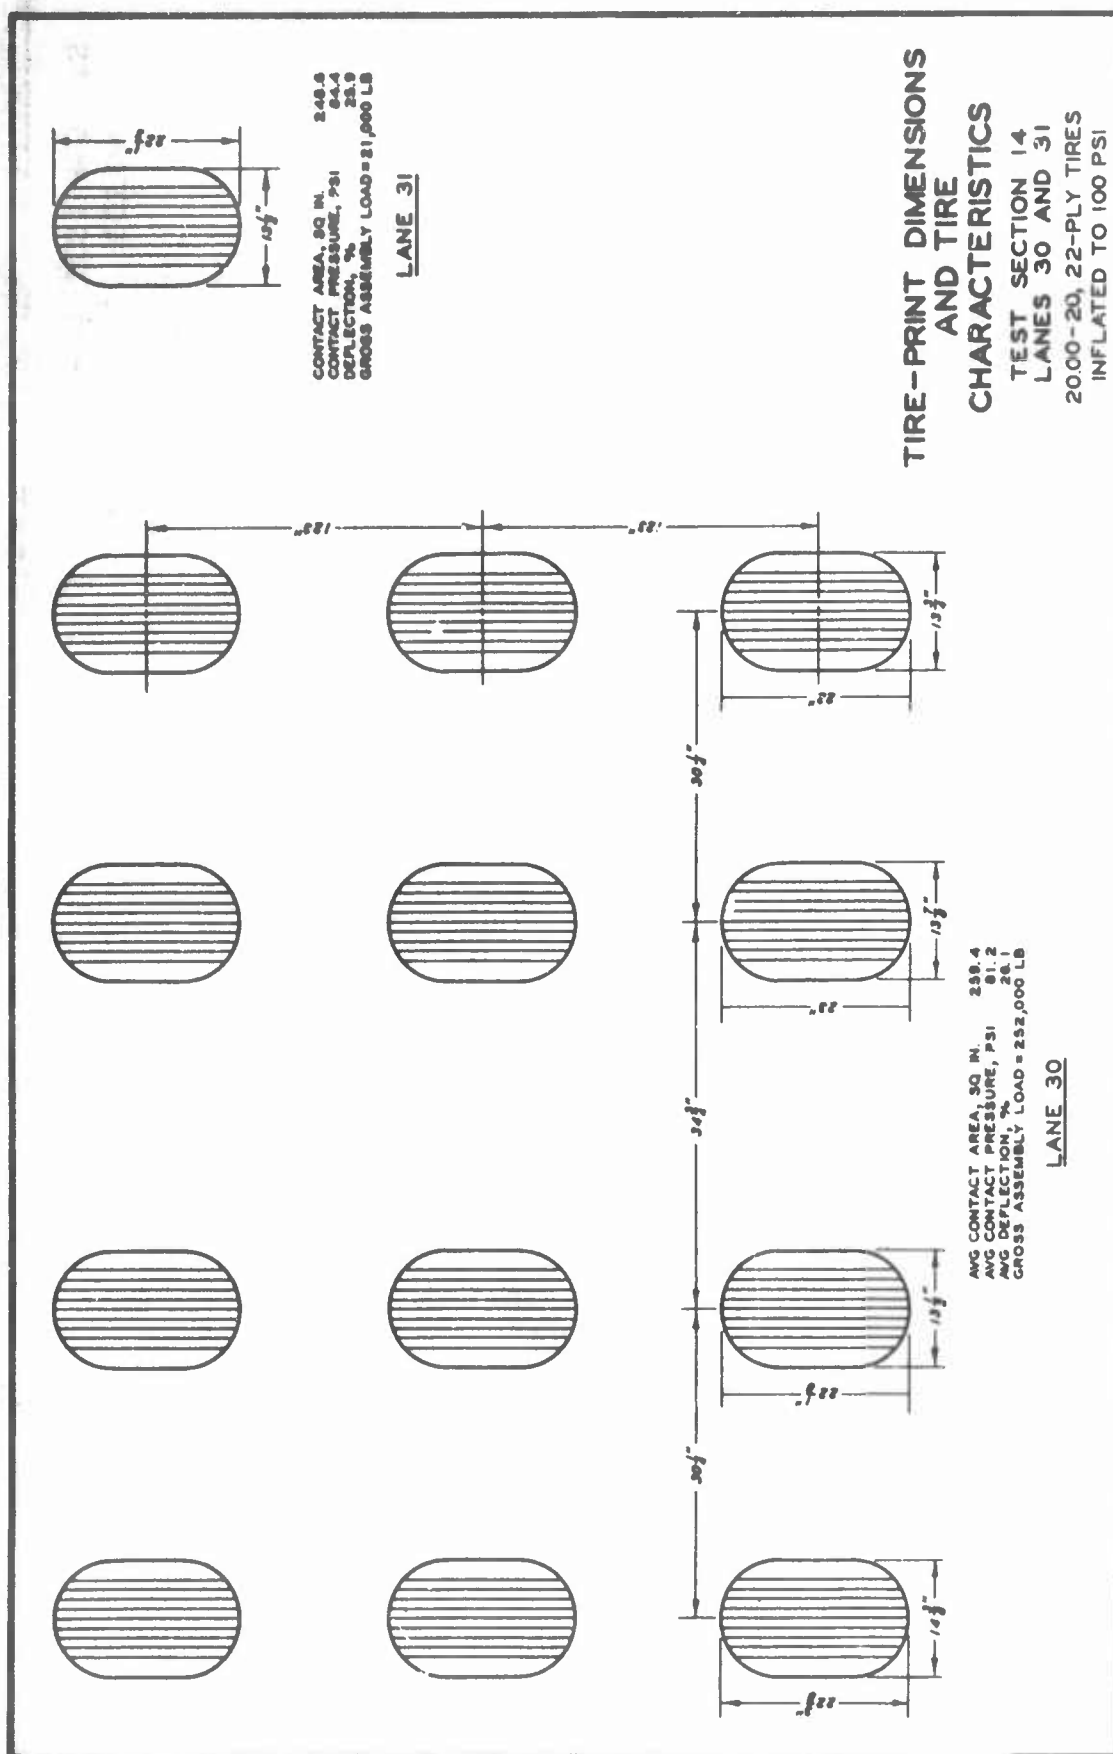
Traffic was applied to lane 30 using a 12-wheel (4 abreast, 3 in line) tracking assembly with 100-psi tire inflation pressure and 252,000-lb loading (21,000 lb per wheel); in lane 31, a single-wheel assembly with 100-psi tire inflation pressure and 21,000-lb loading was used. For trafficking lane 30, the wheel assembly consisted of twelve 20.00-20, 22-ply aircraft tires spaced 30.25-34.75-30.25 in. abreast and 123-123 in. in tandem. For trafficking lane 31, one 20.00-20, 22-ply aircraft tire was used. Figure 14 gives pertinent tire-print dimensions and tire characteristics.

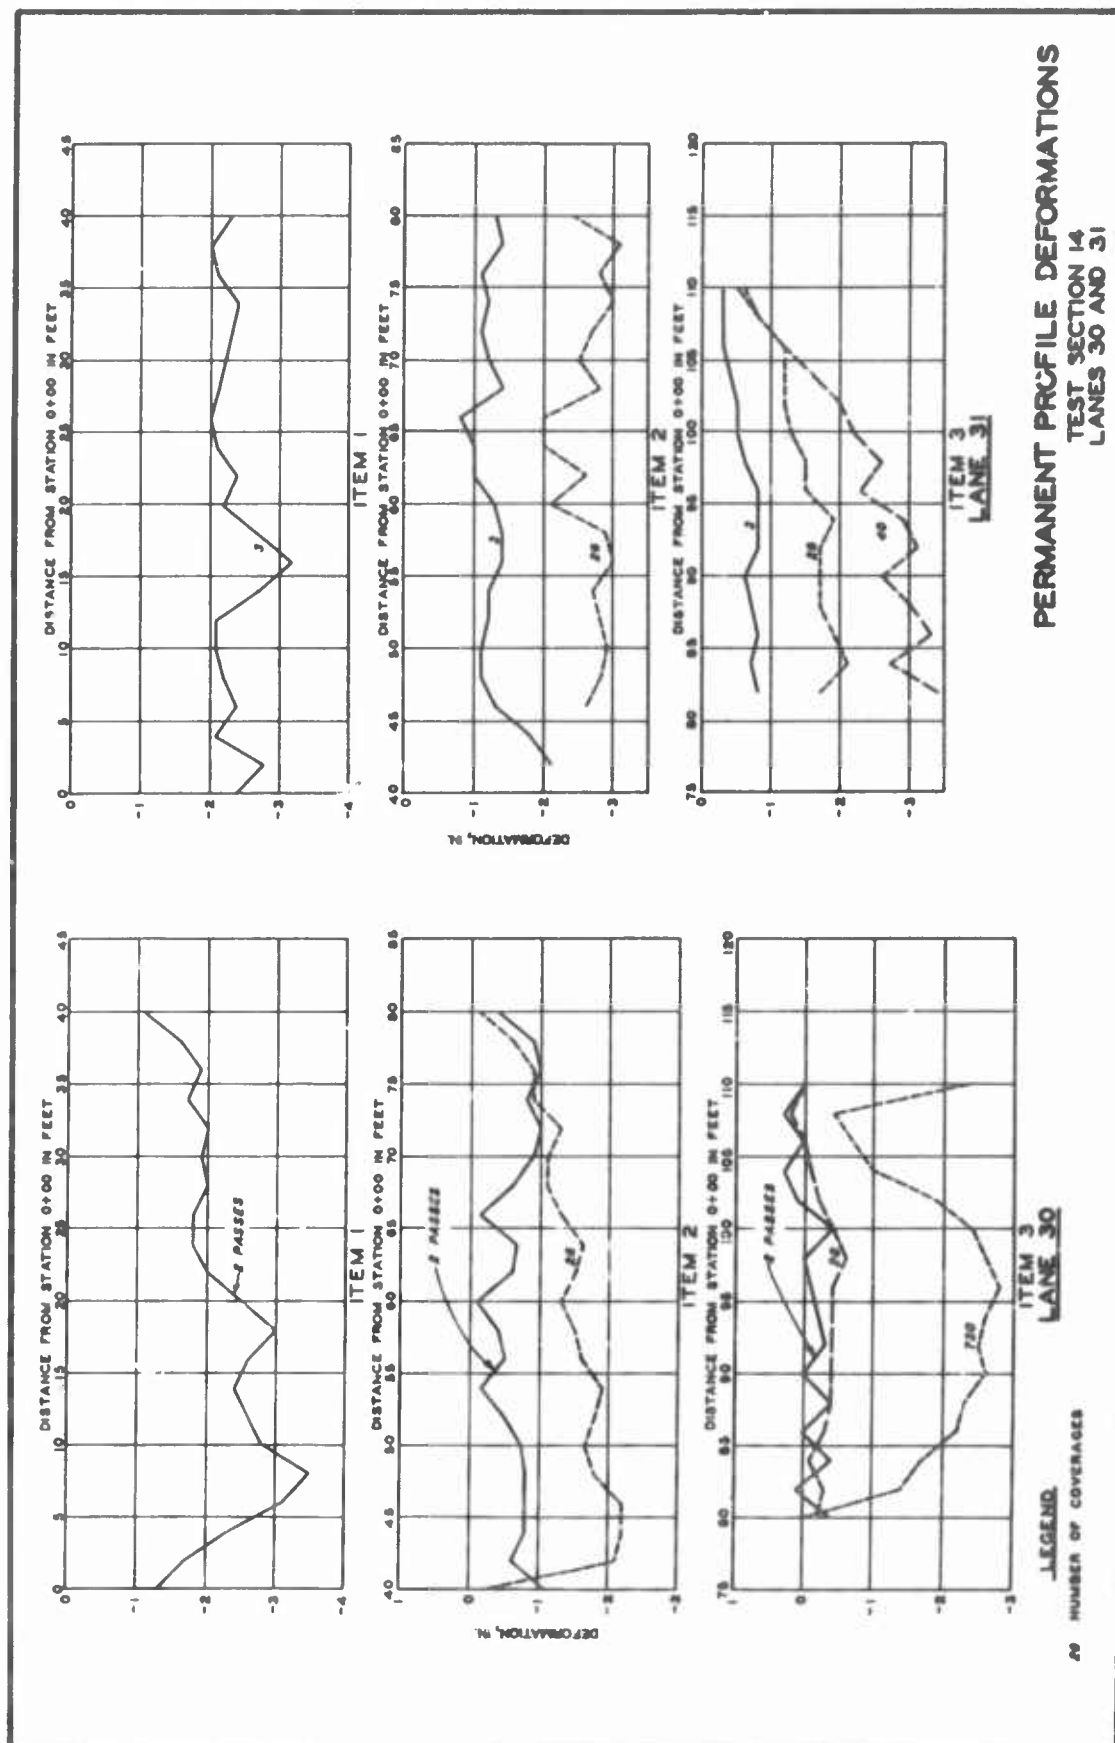
- b. Deformations. Cross-section deformations in figure 15 show the good condition of the item at 28 coverages and the deteriorated condition at failure. The profile deformation in figure 17 particularly illustrates the difference in settlement between 28 and 730 coverages.

- b. Deformations. Cross-section deformations at three locations along the item are shown in figure 16 for 3 and 26 coverages. Figure 17 shows profile deformations along the item and illustrates the general subsidence of the item and progressively increasing longitudinal roughness.

- b. Deformations. Cross-section deformations in figure 16 show the progressive deterioration of the item at 3, 26, and 40 coverages. For the same coverage levels, figure 17 shows profile deformations with corresponding indications of settlement and deterioration.
